UNDERWATER BRIDGE INSPECTION REPORT

STRUCTURE NO. 27537

1ST AVENUE

EAST CHANNEL OF THE MISSISSIPPI RIVER

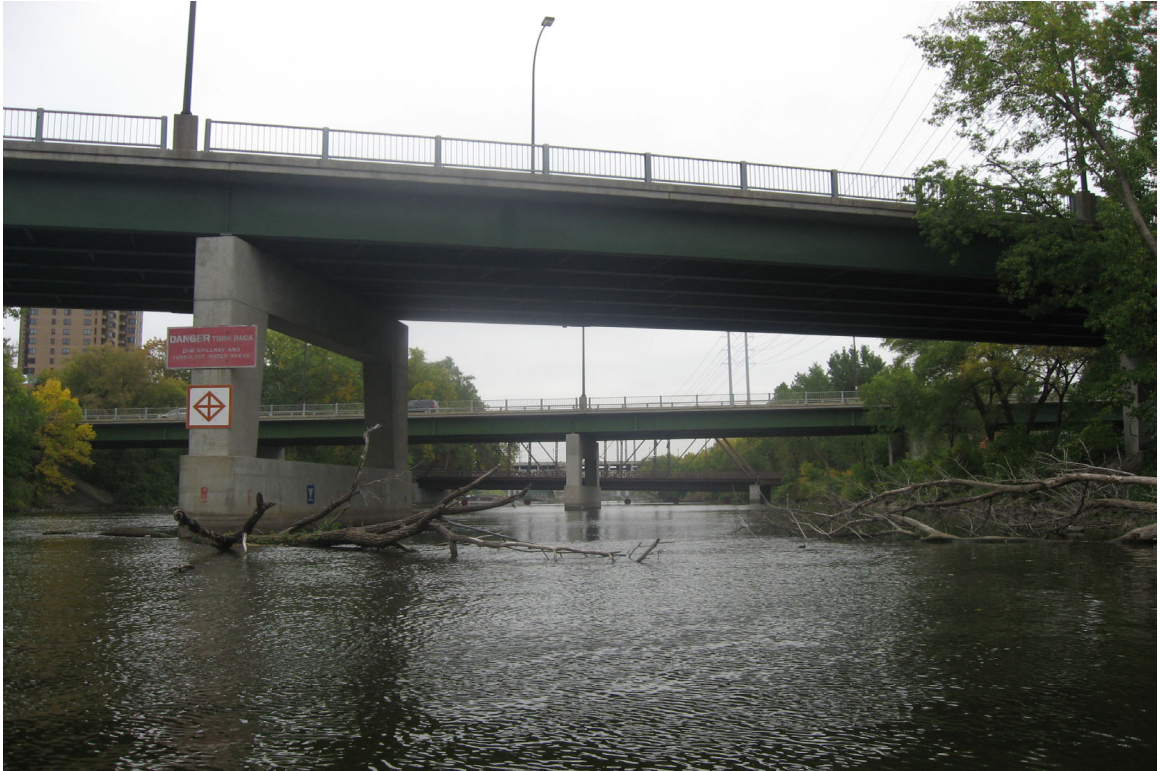
Photograph 1. View of Pier 2 and Timber Debris, Looking Southeast.

- A moderate to heavy accumulation of timber debris was observed at the upstream end of Pier 2 on the channel bottom, consisting of 1-to-2-foot-diameter and smaller logs and branches that extended towards the west shore.

- (A) Monitor the timber debris at Piers 2 and 3, and if found to be increasing in the future, removal operations may become warranted.
- (B) Reinspect the submerged substructure units at the normal maximum recommended (NBIS) interval of five (5) years.

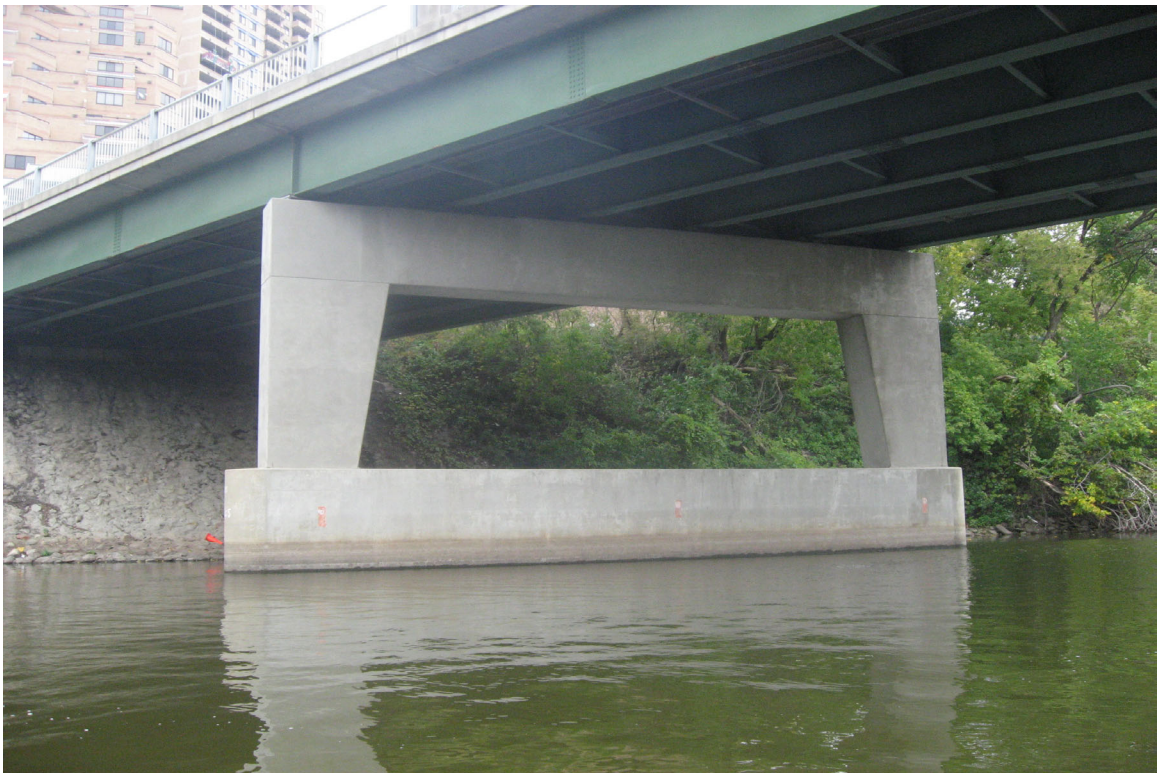
Photograph 2. View of Pier 3, Looking East.

- A light accumulation of timber debris, consisting of 1 foot-diameter, logs and branches was observed at the upstream end of Pier 3.
- Both embankments were well armored with grouted riprap.

- Vertical cracks 1/16 inch wide were observed along the west face of Pier 3, extending from channel bottom to top of pier shaft.
- Overall concrete was smooth and sound.

- Footing exposure (top at 6.2 feet below waterline) was observed at the west face of Pier 3. The footing's surface was rough with some irregularities. Steel sheet piling was observed along footing from the midpoint to the downstream nose with a maximum vertical exposure of 1 foot (footing and sheeting).

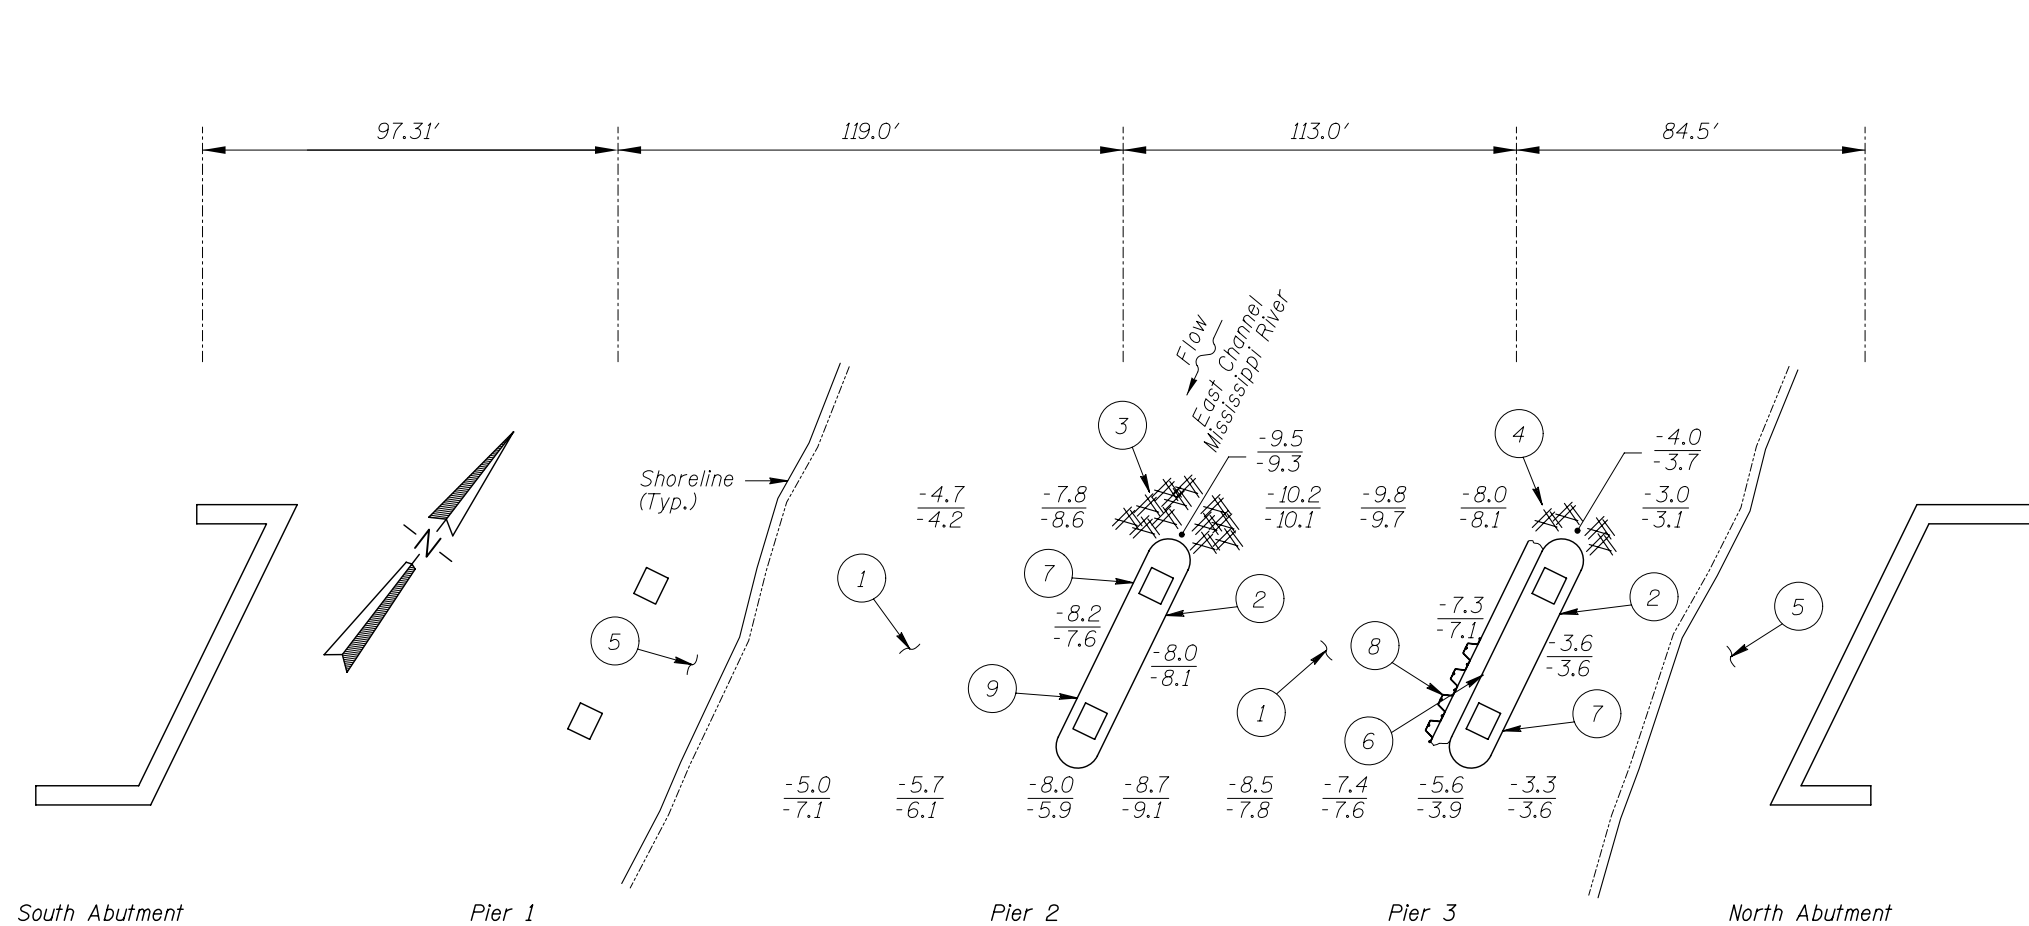
INSPECTION AND SOUNDING PLAN

- The channel bottom consisted of silty sand and scattered cobbles with up to 1 foot of probe rod penetration.
- The concrete piers exhibited light scaling from 1.5 foot above to 1 foot below the waterline.

- Vertical cracks (1/16 inch maximum width) were observed along east face (5 cracks) and west face (3 cracks) of Pier 2, extending from channel bottom to top of pier shaft.
